## **ANSI/SPRI ES-1 PERFORMANCE TEST REPORT**

**SOUTHERN ALUMINUM FINISHING COMPANY, INC.**

***Press-Loc®* Aluminum Edge Flashing and Coping**

**Report No.: D6438.01-119-16**

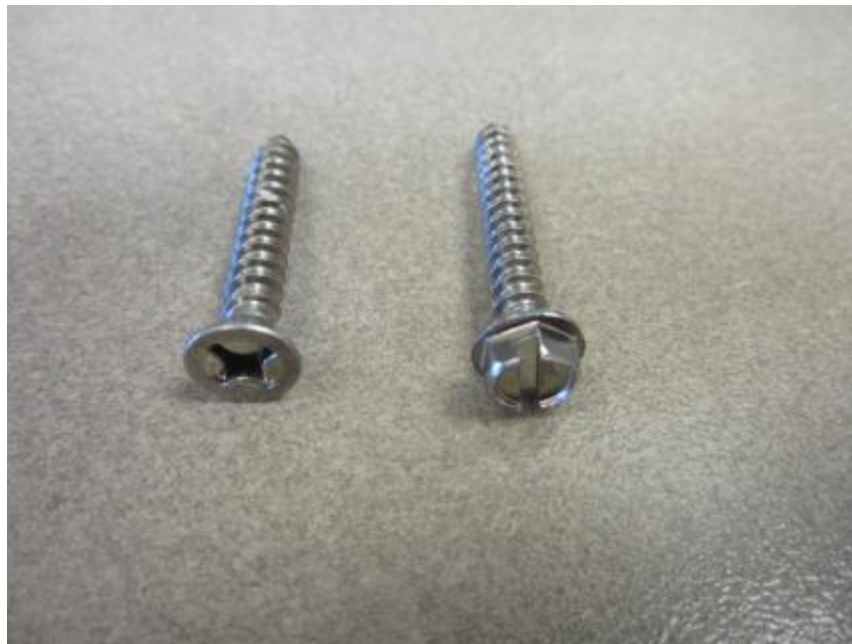
**Photo No. 11**

**#10 x 1-1/2 in (0.158 in minor diameter) Flat head, Phillips-drive, Stainless Steel Screw**  
**#10 x 1-3/4 in (0.156 in minor diameter) Hex-head, Stainless Steel Screw**
